## Application report

### crash simulation of a vehicle battery tray

Graz University of Technology  
Laboratory for Structural Engineering  
in cooperation with the Institute of  
Automotive Engineering

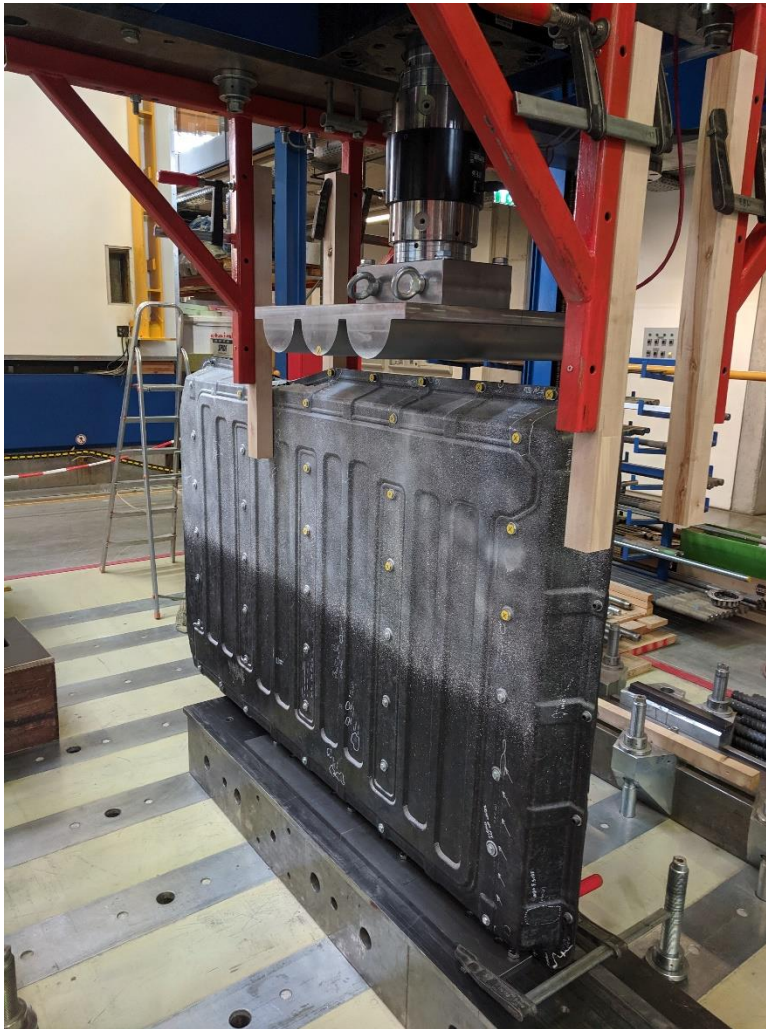
For this test, the interior of the battery tray was replaced by comparable parts made of concrete. The lateral structure of the battery tray was loaded at two points by means of a special load introduction construction. Basically, two aspects were at stake. Firstly, the fracture behaviour of the tray at the contact point and secondly, the deformation of the tray due to the displacement of the internal components. The measurement of the deformation should be recorded in the area of the load application up to approximately the middle of the tray. In addition to the deformations, strains on the carbon fibre construction were also to be recorded.

Mercury was used as a stereo sensor to obtain a 3D model of the tray.

In this case, only white dots were sprayed onto the matt grey surface of the tray. In addition, the screw connection points were covered with measuring marks so that these could be used as measuring positions.

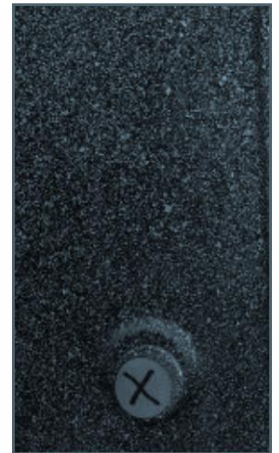
*Point probe evaluation displacements [mm]*

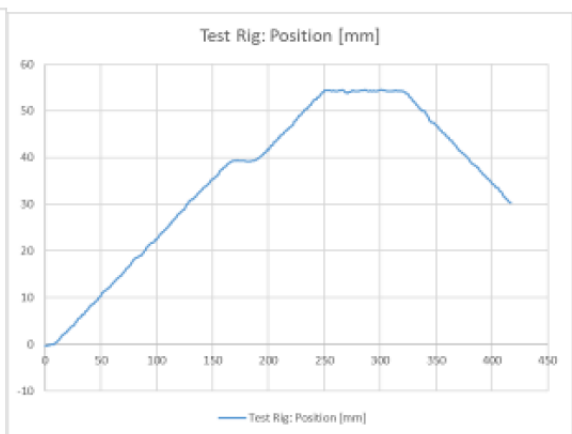
Line probe, evaluation strains [%]
